Project No. 1-Lo143.17
Lab Ref No. 001/14
Page 1 of 8

INTRUDER RESISTANCE TESTING

Carry out testing to determine the resistance to attack properties of glass panels supplied by client following the method as described in AS 3555.1-2003
(Level 2 – two men using common hand tools.)

INTRUDER RESISTANCE TESTING - JAILGUARD 30

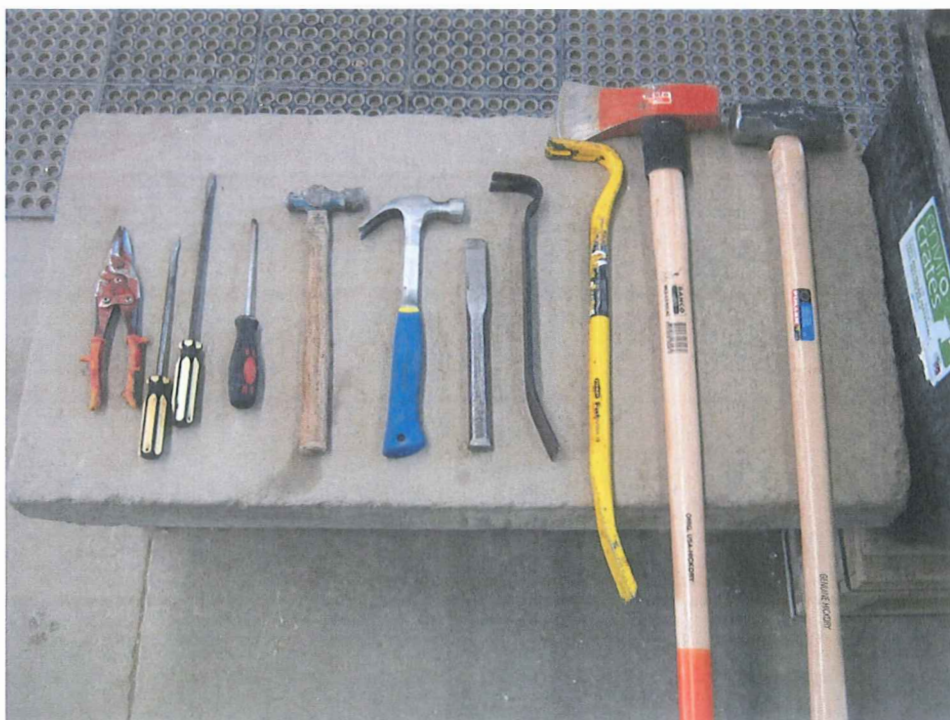
The tools provided were, as shown below. The sledgehammer, prybar and axe did not weigh more than 3.6kg or were greater than 1.5m in length.
(as per AS 3555.1-2003, clause 1.4.2)

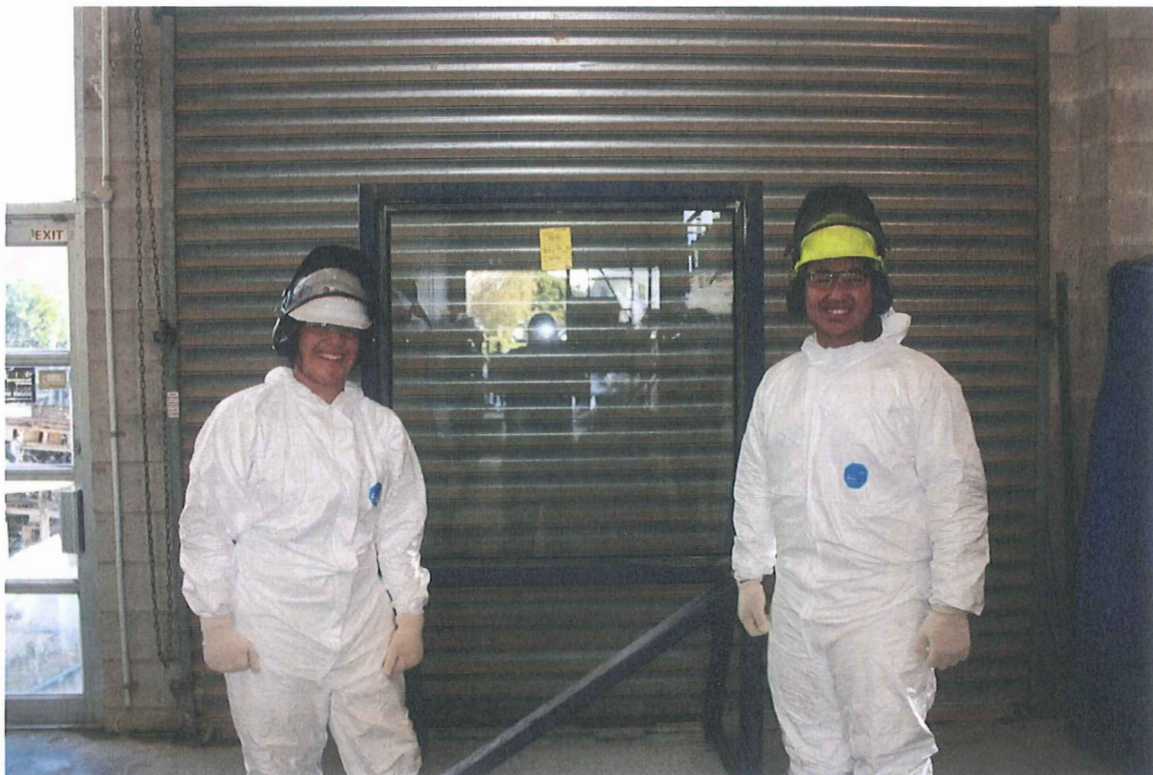
Panel 2 and attackers

The initial attack started slowly using a hammer and screwdriver. The attackers then changed to using the sledgehammer and the glazing tape used to fix the pane into the frame dislodged in the bottom fixing.

The attack continued using the axe. The intensity was slow to start but increased with time.

There was interchanging of attackers with both the sledgehammer and the axe. An attempt was made to cut the interlayer using a hammer and screwdriver. This was followed with a hard out attack with the axe followed by attempting to cut the interlayer with the axe.

The sledgehammer was then used to remove all of the glass to weaken the pane. The axe and crowbar were used and then tried again to cut the interlayer using a screwdriver and sharpened trowel.

After 10 minutes no penetration or opening was achieved.

Very high intensity testing then continued for an extra period of 3 minutes.
Still no penetration or opening could be achieved.

Therefore the rating on the JailGuard 10 Glass Panel was Level 2 (10+minutes)

Test Result	No Failure
Comment	-
Average Test Intensity	Medium to High
Rating achieved	Level 2 (10+ Minutes)

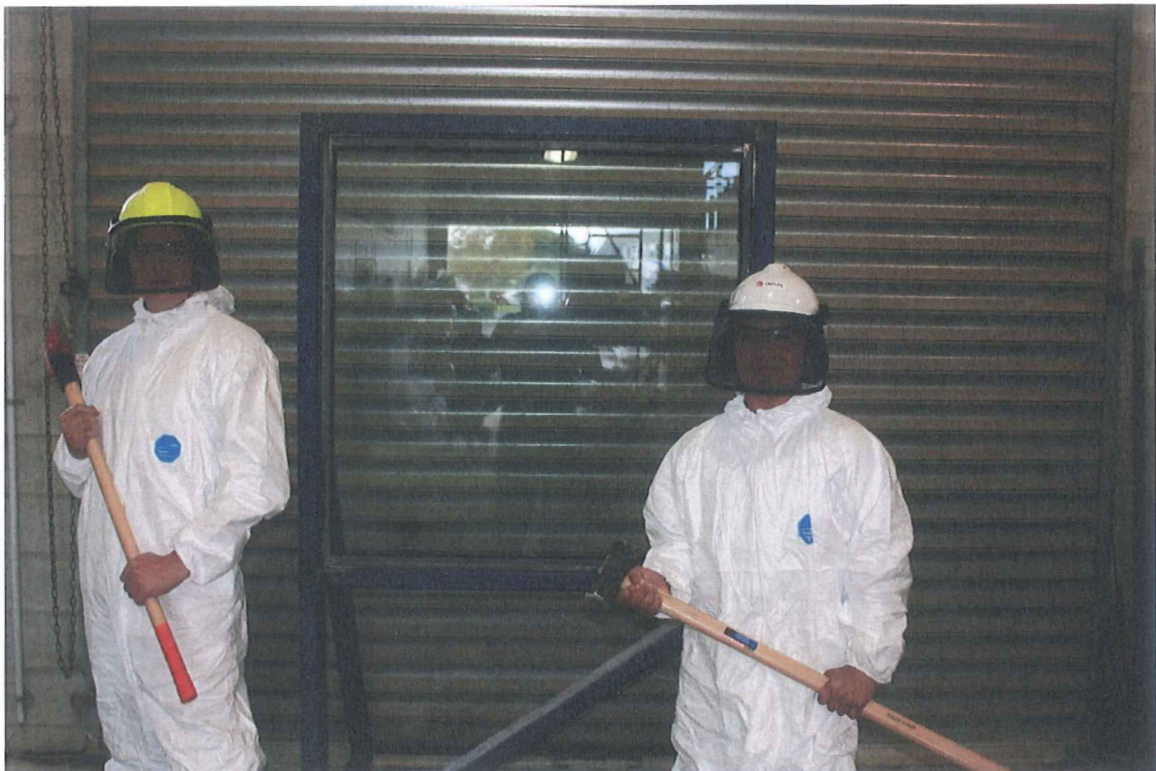
Panel 3 and attackers

The attackers started off using the back of the axe and attacking the top left hand corner of the pane. Attackers changed and the sledgehammer was used on the top right hand corner of the pane and the glazing tape used to fix the pane into the frame dislodged in these attack areas. (See photo on following page)

The attack then changed to the bottom corners.

An attempt was made using first off a screwdriver and then the crowbar to pry the pane from the frame, to no avail.

The attack continued using the sledgehammer and the axe and once again there was an attempt made using the crowbar to pry the pane from the frame, again to no avail.

An attempt was made using the hammer and screwdriver to break through the interlayer. No success so back to the sledgehammer and the axe.

Another attempt was made to pry the pane from the frame, again to no avail so back to the sledgehammer.

The axe was then used to remove all the glass from the pane along the bottom and sides. Again an attempt was made using the hammer and screwdriver to break through the interlayer. No success

Steveland was replaced by Opus employee Troy due to blisters.
The interlayer was attacked with cutters followed by the axe in the same area.

Test Result	No Failure
Comment	-
Average Test Intensity	Very high
Rating achieved	Level 2 (20+ Minutes)

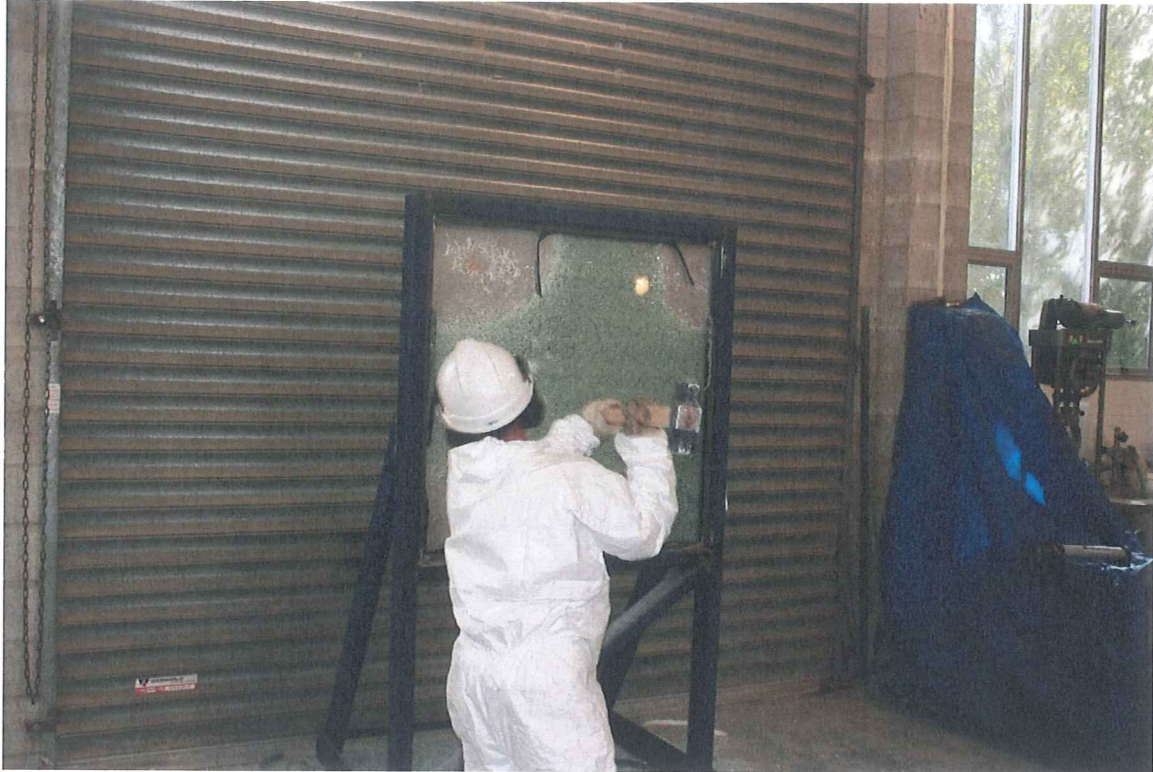
Attack on the top corners of the pane.

After 20 minutes no penetration or opening was achieved.

Therefore the rating on the JailGuard 20 Glass Panel was Level 2 (20+minutes)

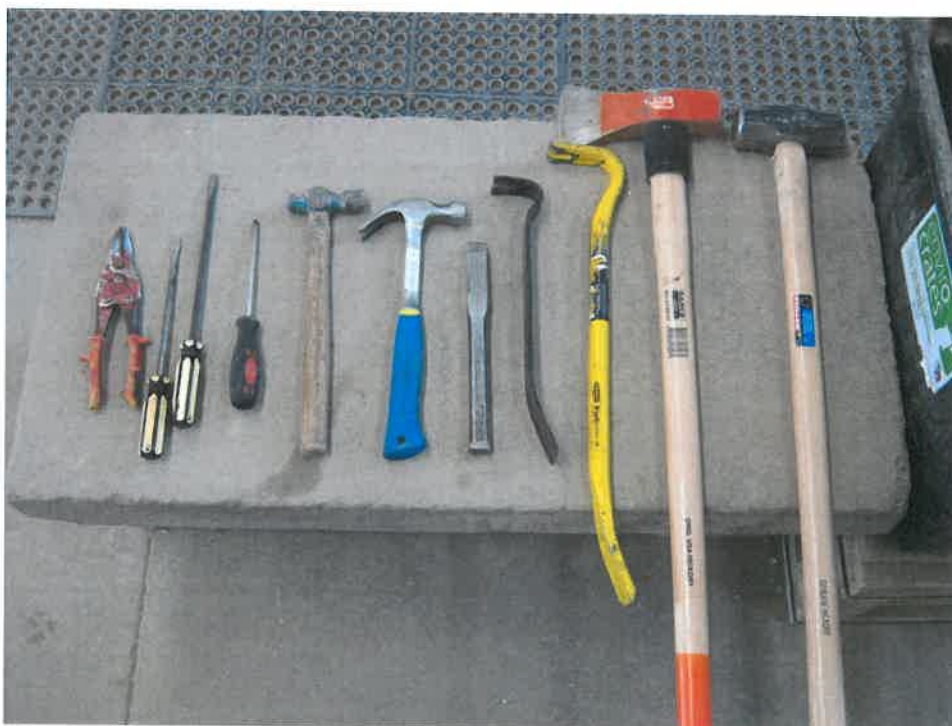
The tools provided were, as shown below. The sledgehammer, prybar and axe did not weigh more than 3.6kg or were greater than 1.5m in length.
(as per AS 3555.1-2003, clause 1.4.2)

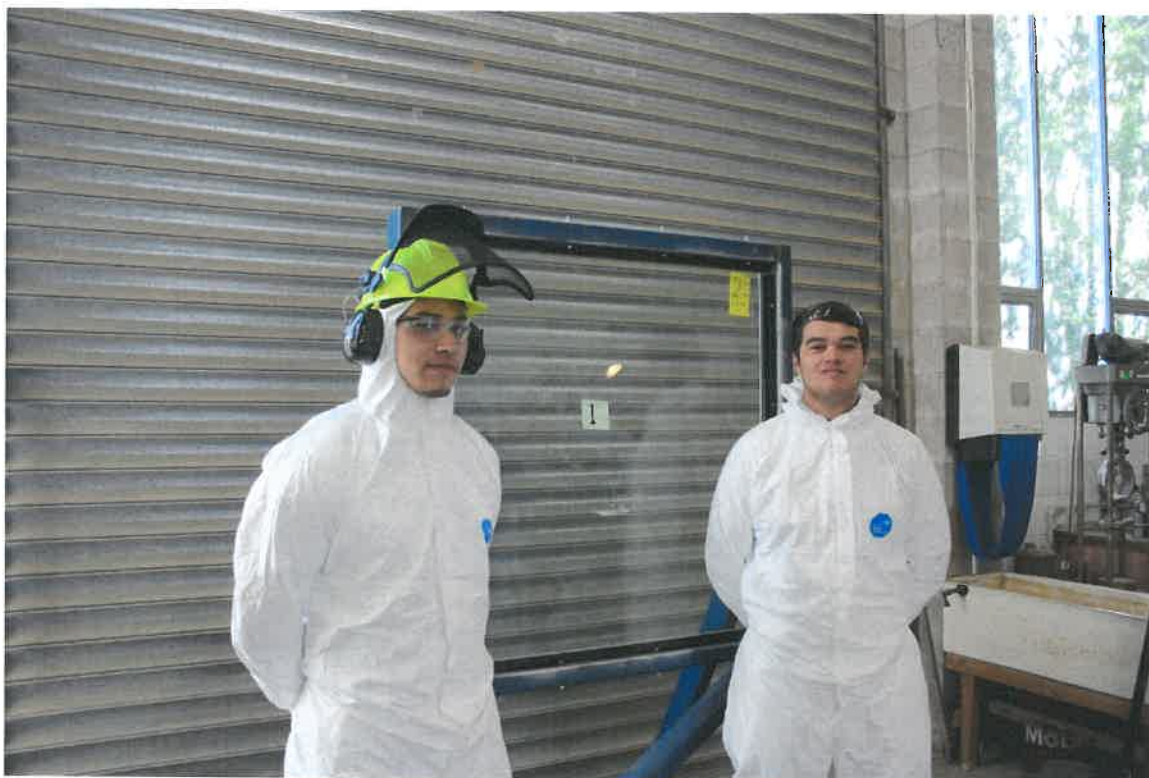
Panel and attackers

The initial attack started with interchanging of attackers using the axe with a change to using the sledgehammer and the crowbar.
The attack was concentrated on the top right centre of the pane.

Damage (minor) to the interlayer was noticed by the attackers and they tried to cut the interlayer using a hammer and screwdriver in the same area.

This was unsuccessful and the attack then changed to using the axe – crowbar – axe – sledgehammer – axe still in the same area.

The attack then changed to a lower area in an attempt to remove all the glass.

After approx 16 minutes the glazing tape used to fix the pane into the frame dislodged in the bottom fixing area. The attack moved to the RHS and LHS where again the glazing tape was dislodged and at approx 20 minutes the pane started to move in the frame.

The axe and sledgehammer was then used to remove all of the glass around the outer edges of the pane.

As the pane became looser in the frame the crowbar followed by the hammer and screwdriver were used to try and prise the pane from the frame. This was unsuccessful and there was interchanging of attackers with both the sledgehammer and the axe.

After 30 minutes no penetration or opening was achieved.

Therefore the rating on the JailGuard 30 Glass Panel was Level 2 (30+minutes)

No Failure
-
High to very high
Level 2 (30+ Minutes)

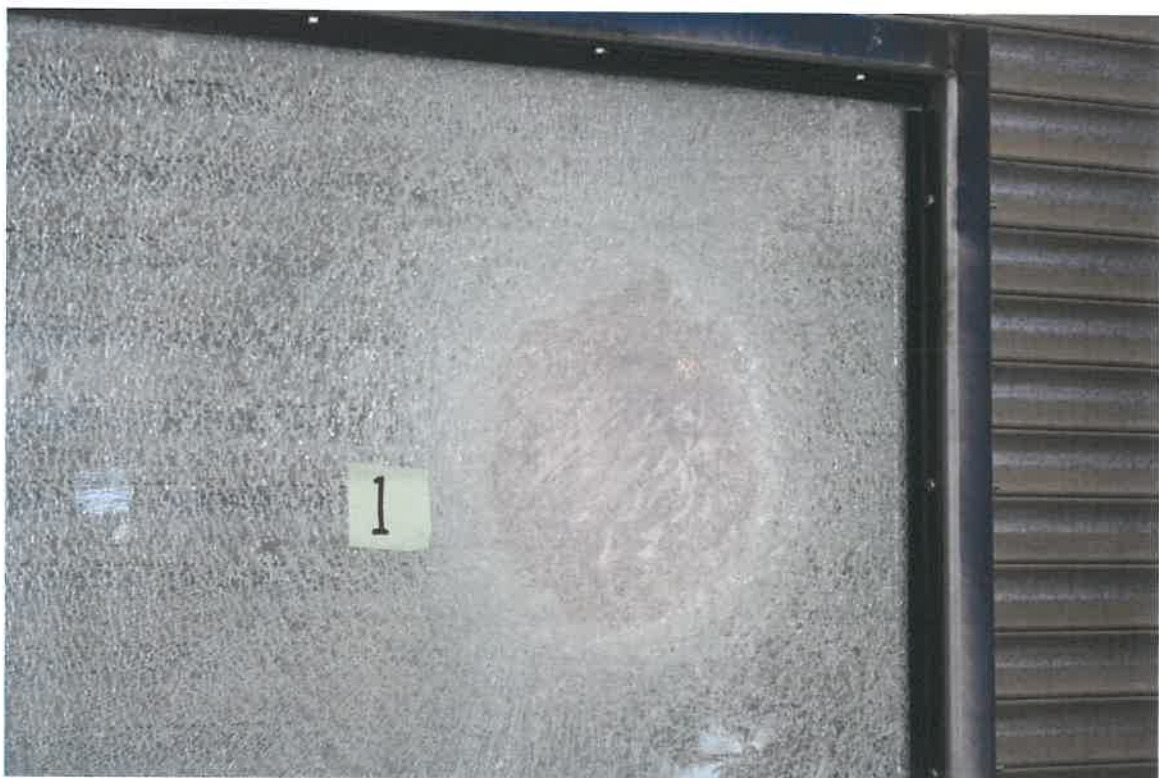
Initial attack was concentrated on the top right centre of the pane.

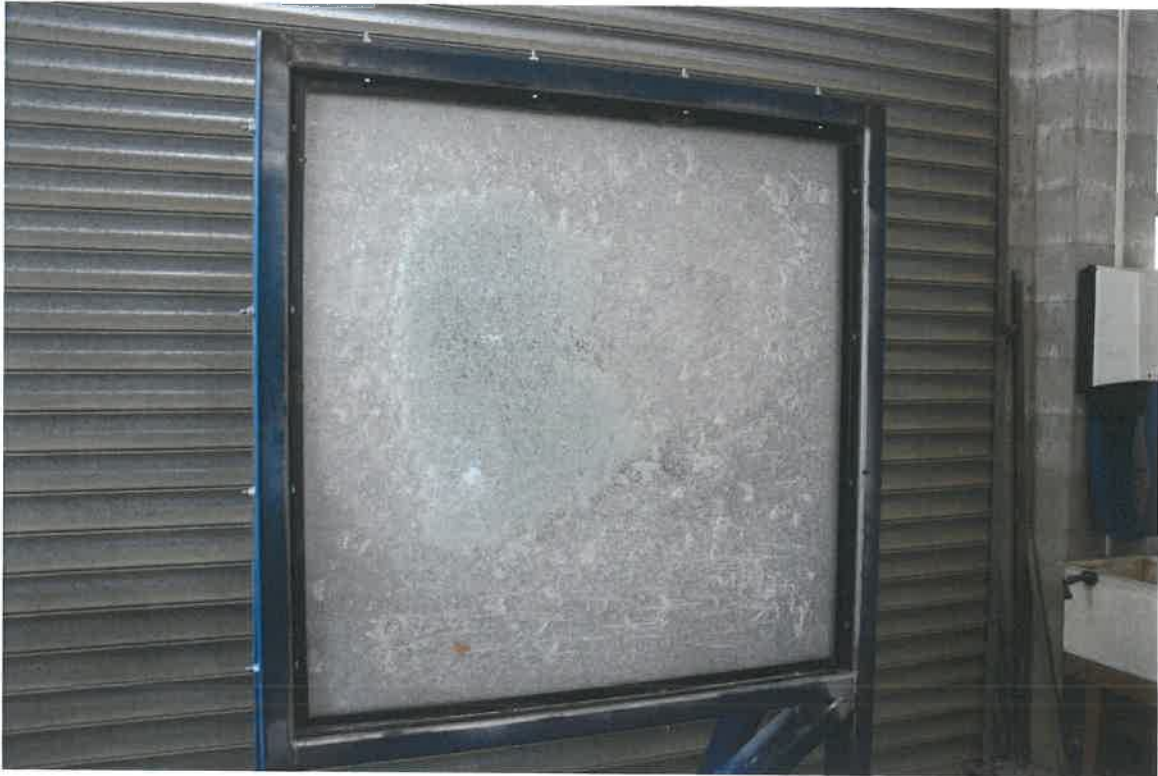
Pane after 30minutes showing no penetration or opening
